# An absorbing process

A new way of assessing the residual strength in bridge cable wire is being applied in the USA. *Khaled Mahmoud* explains the process and its application

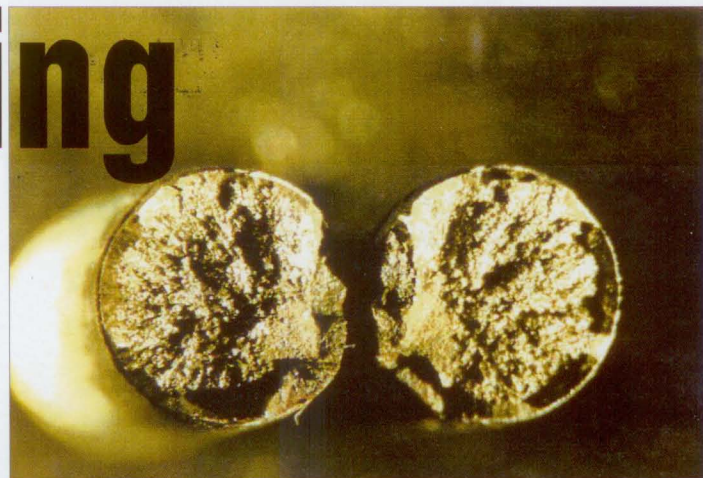
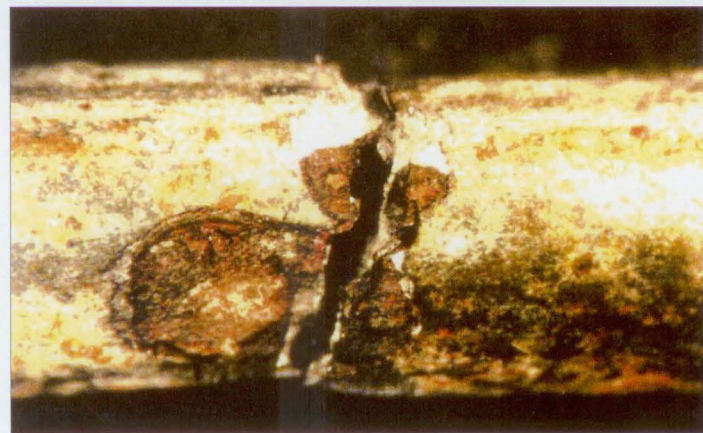
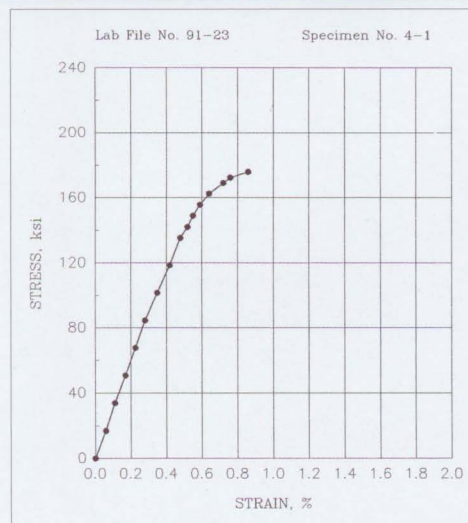
Hydrogen embrittlement showing;

Top: Tension specimen with low ductility

Middle: Side view with minimal necking

Right: Stress-strain curve

The loss of ductility, due to environmental deterioration, is not always manifested in a wire cross-sectional area reduction. On the contrary, under the influence of hydrogen embrittlement, the area reduction may be quite inconsequential, while the ductility loss is significant. The images on this page demonstrate a fractured wire specimen with minimal necking. The stress-strain curve of the same specimen reveals a significant reduction in elongation at failure. In this case, reduced ductility, along with virtually non-reduced cross-section, is suggestive of a hydrogen embrittlement regime of fracture. The opposite page shows a wire specimen with a typical cup and cone fracture. The elongation, though about one-third of a new wire, is almost double that of the embrittled wire shown on this page, more suggestive of a stress corrosion mode of failure. This indicates that the effect of hydrogenation is mirrored in the reduced ductility of the wire material and not in the effective cross-sectional area.

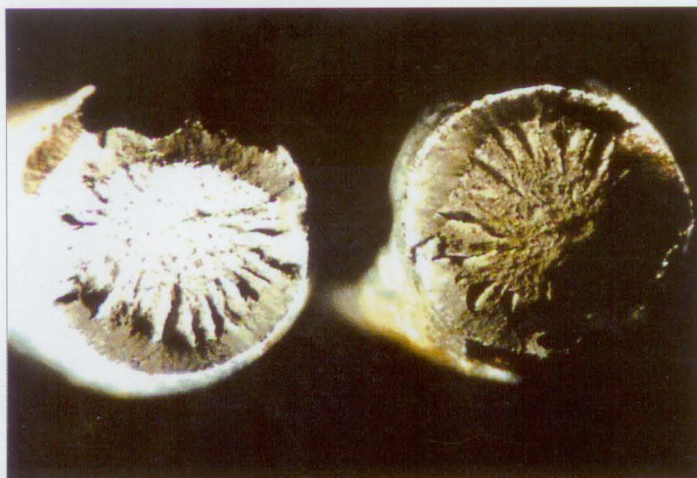
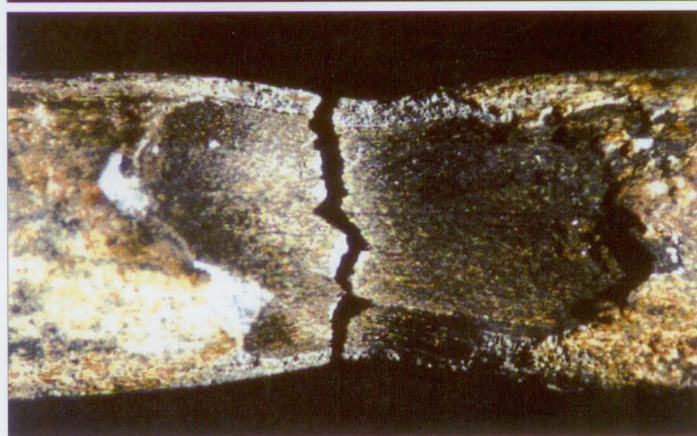
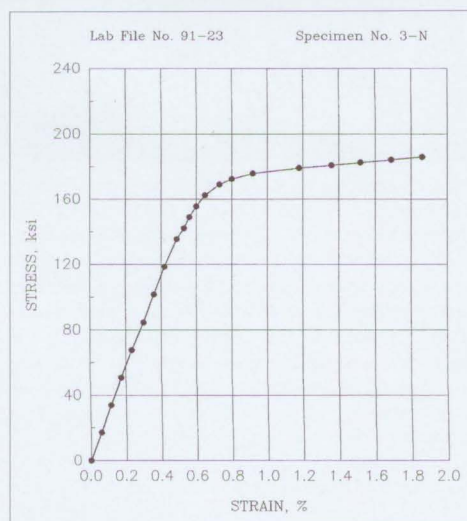
Stress corrosion cracking showing;

Left: Tension specimen with cup & cone fracture

Below left: Side view with appreciable necking

Right: Stress-strain curve

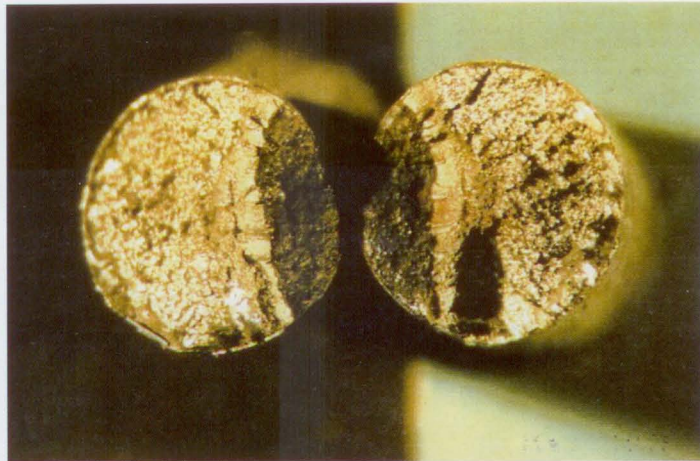
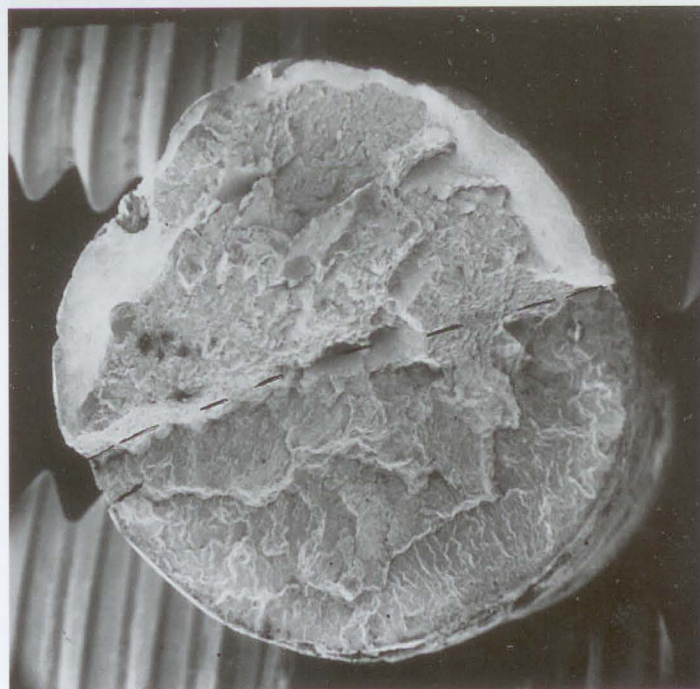
Top right: Semicircular crack front

Right: Straight crack front

Constructing an analytical model for the combined effects of loading and environment is an important milestone in addressing the role of environmental factors in accelerating the crack growth in bridge cable wires. A new model has been developed for the assessment of fracture toughness of deteriorated cable wires. This model determines the mode of wire fracture - stress corrosion or hydrogen embrittlement - through the examination of broken wire surfaces using scanning electron microscopy and the stress-strain curve of tested wire samples. In studying the notch toughness of cable wires, a surface edge-crack subject to tensile stress is considered the prevalent mode of fracture. In this mode, also known as the opening mode, the tensile stress is applied normal to the faces of the crack. To develop the appropriate stress intensity factor and its critical value, fracture toughness, it is necessary to accurately determine the crack geometry. Examination of broken wires indicates that surface cracks undergo a shape change. The crack tends to assume a semicircular front very early in the crack growth process. As the

crack extends, its front tends to flatten and approaches a straight shape. The new model provides a solution to the stress intensity factor covering the entire range of the crack growth process for axial tension and for the bending stress resulting from straightening the wire. Finally, the fracture toughness of the wire is determined based on the measured crack depth at failure. The model also correlates the strain energy density evaluated from the stress-strain curve of wire samples to the fracture toughness. This latter approach allows the engineer to use the recorded history of wire breaks to establish the pattern of deterioration in the cable wires based on the fracture analysis of data. The estimated values for the fracture toughness are then used to assess the remaining safe life of the bridge cables.
